Managing the Eurasian Watermilfoil on Farlain Lake

Where are we at and what's next?

The following article provides a report on our efforts to manage this invasive aquatic plant in 2018 and indicate what's next.

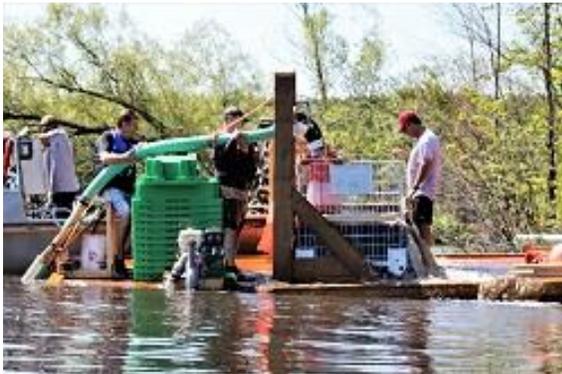
Last year the FLCA developed a prototype Diver Assisted Suction Harvesting (DASH) system to expedite the transport of harvested EWM plants to the water surface via a suction hose. The harvested plants are collected on a floating work platform and disposed of on land. DASH does not remove lake sediments. With the experimental DASH unit we were able to remove in excess of 5200 lbs. of EWM from the pioneer colony in July 2017.

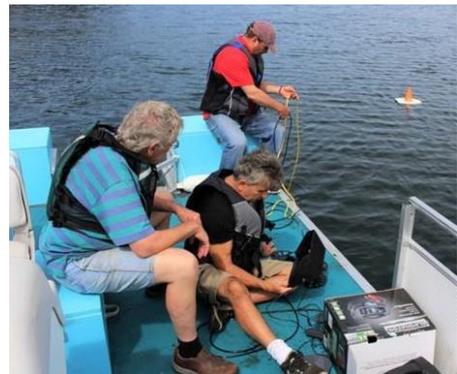
Based on our knowledge and experience from 2017 a more aggressive approach was taken in 2018. Included in this action was the purchase and reconfiguration of a used pontoon boat which provided an invaluable multi-purpose tool for EWM searching, mapping, and marking, deploying the plant dispersal containment curtain around the work sites, serving as the work platform for the FLCA's prototype DASH system, and assessing the results of the work undertaken this year.

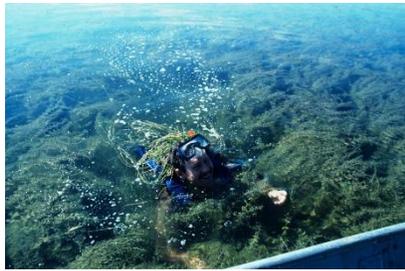
In July, EWM in the pioneer colony and one other offshore infestation were treated with the aquatic herbicide *Reward* by a licensed applicator under a permit issued by the Ministry of Environment, Conservation, and Parks. *Reward* is the only aquatic herbicide permitted by Health Canada to manage invasive and nuisance aquatic plants. It is a contact herbicide that only kills the plant tissues (e.g. leaves, stems) exposed to the chemical but does not kill the EWM and native aquatic plants. Since it is heavier than water, it sinks, reaching the targeted area rather than spreading across the surface of the water.

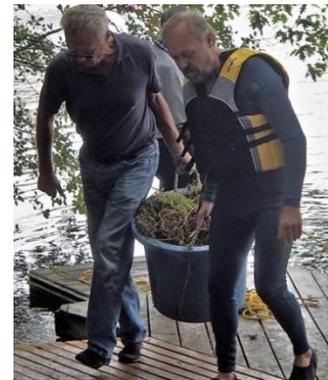
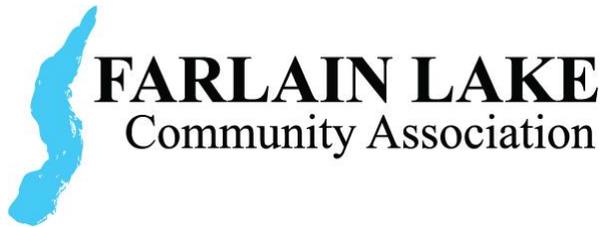
Prior to deployment of the burlap barrier, the divers hand-cut the dense EWM vegetation near the base of the plant allowing a roll of burlap to lay flat over the crowns (root mass) of the EWM plants. Since bottom barriers prevent sunlight from reaching aquatic plants, EWM plants will die within several months. With divers in the water aided by FLCA volunteers on the surface, the roll of burlap barrier was rolled out along the lake bottom to cover the monoculture of EWM plants.

The divers also used the FLCA DASH system to remove smaller clusters of EWM on the perimeter of the dense EWM in the pioneer colony. During the three day control event, the FLCA pontoon boat supported volunteer divers hand harvesting EWM plants from the bay at the north end of the lake.

The combined efforts of hand cutting EWM and hand harvesting EWM using the DASH system resulted in 15 cubic yards of EWM biomass being removed from the pioneer colony. This amount of invasive aquatic plant material would be equivalent to the amount of material carried in a standard two axle dump truck. Removing the EWM from the pioneer colony at the end of August would restrict the plant's ability to 'auto fragment' pieces of the plant at the end of its growth cycle. Plant fragments are carried by wind and wave action to other parts of the lake to possibly form into new plant colonies.
